DOI FY 05 Aviation Mishaps

**5 Aircraft
Accidents**

**9 Incidents
with Potential**

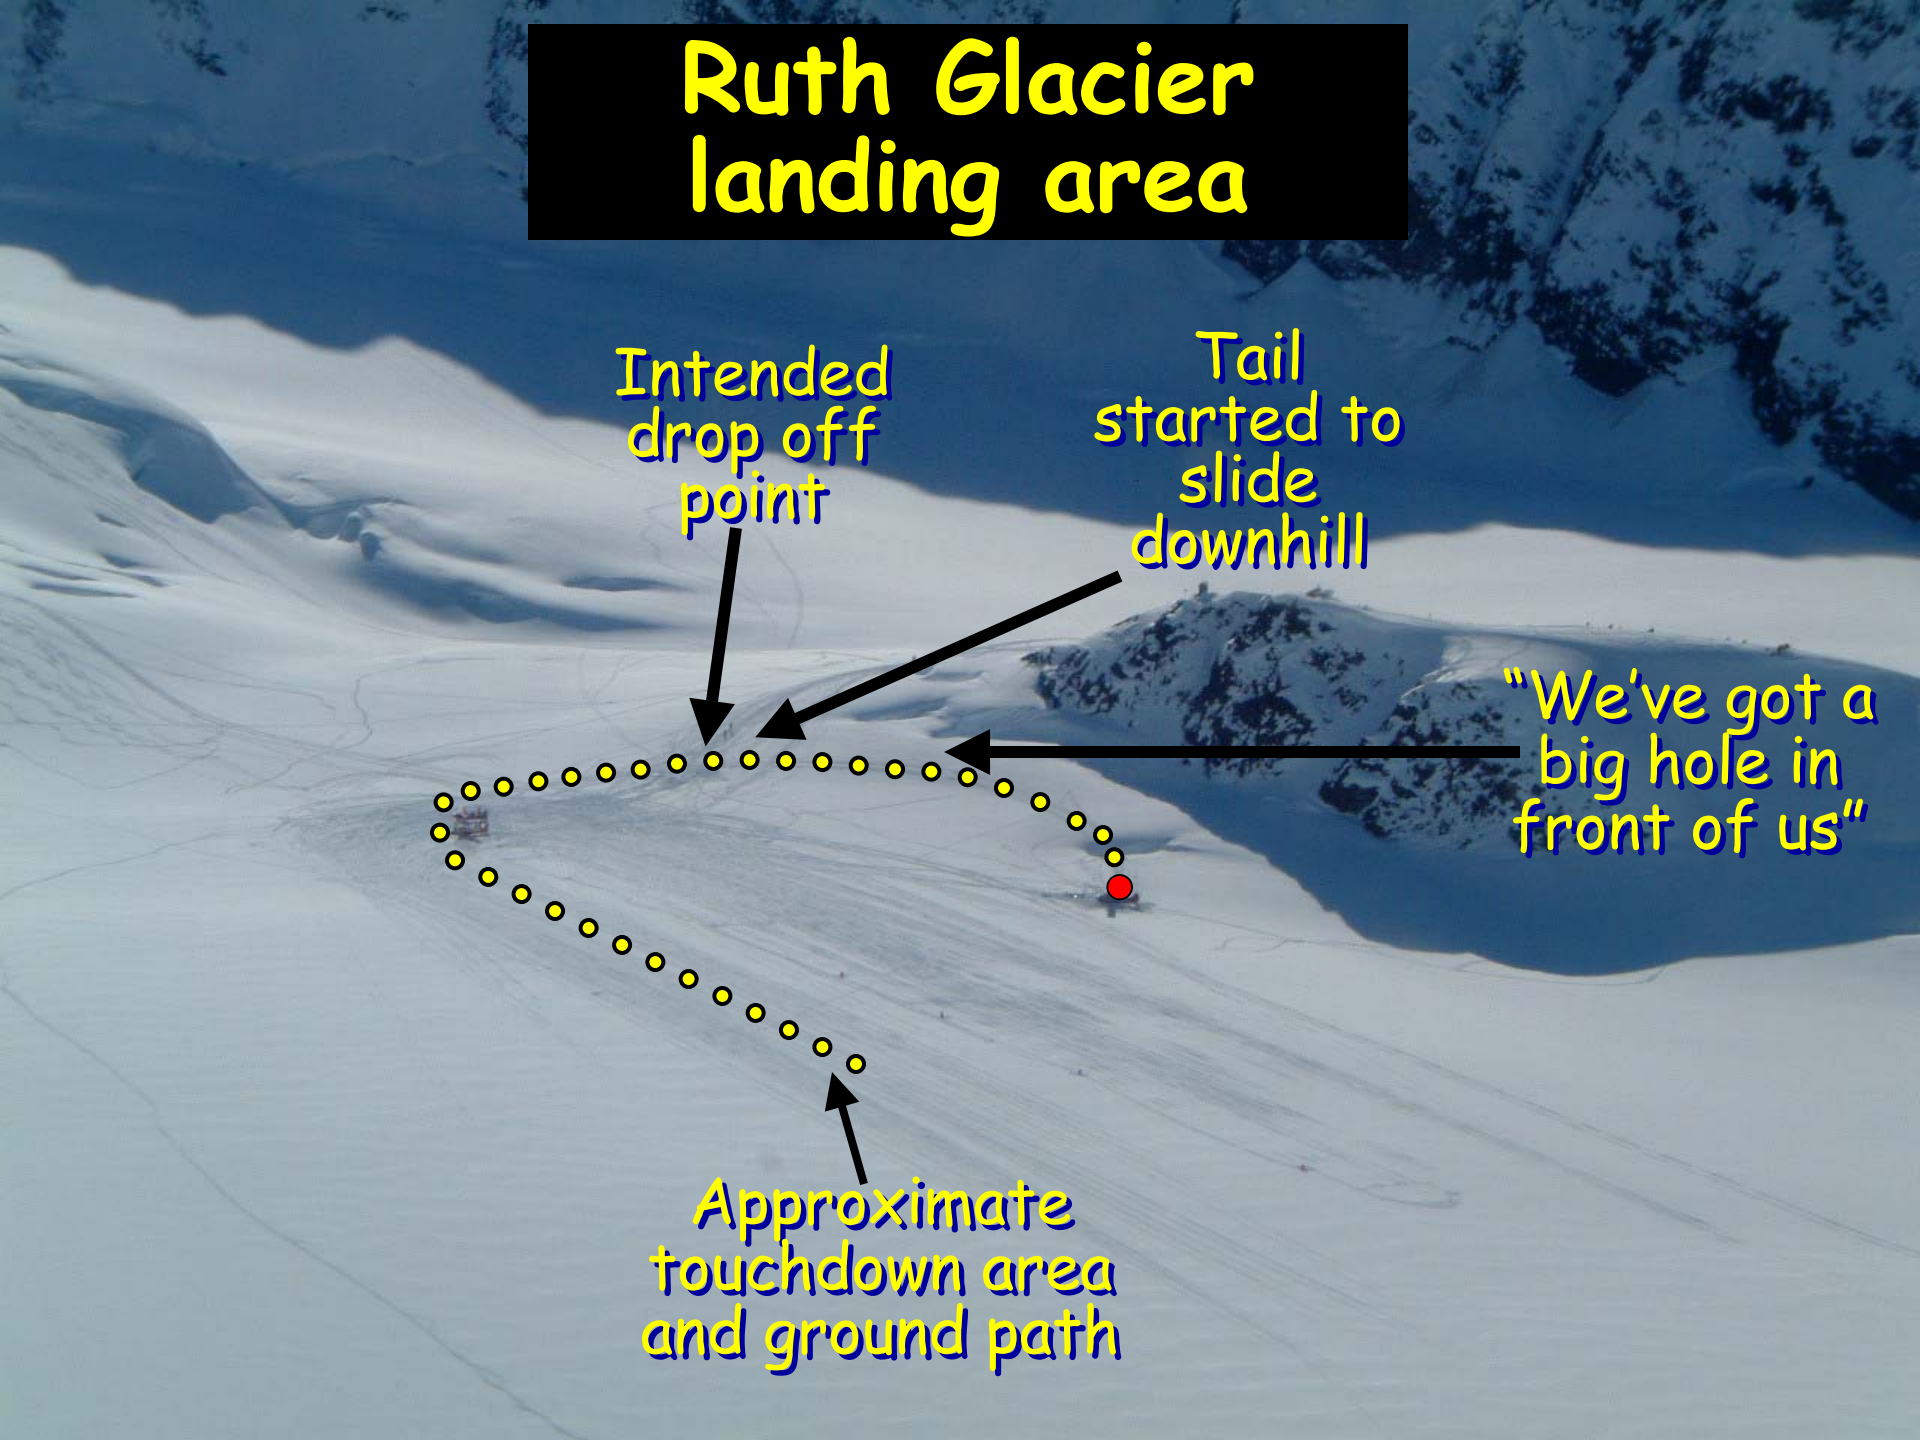
Ruth Glacier landing area

Intended
drop off
point

Tail
started to
slide
downhill

"We've got a
big hole in
front of us"

Approximate
touchdown area
and ground path

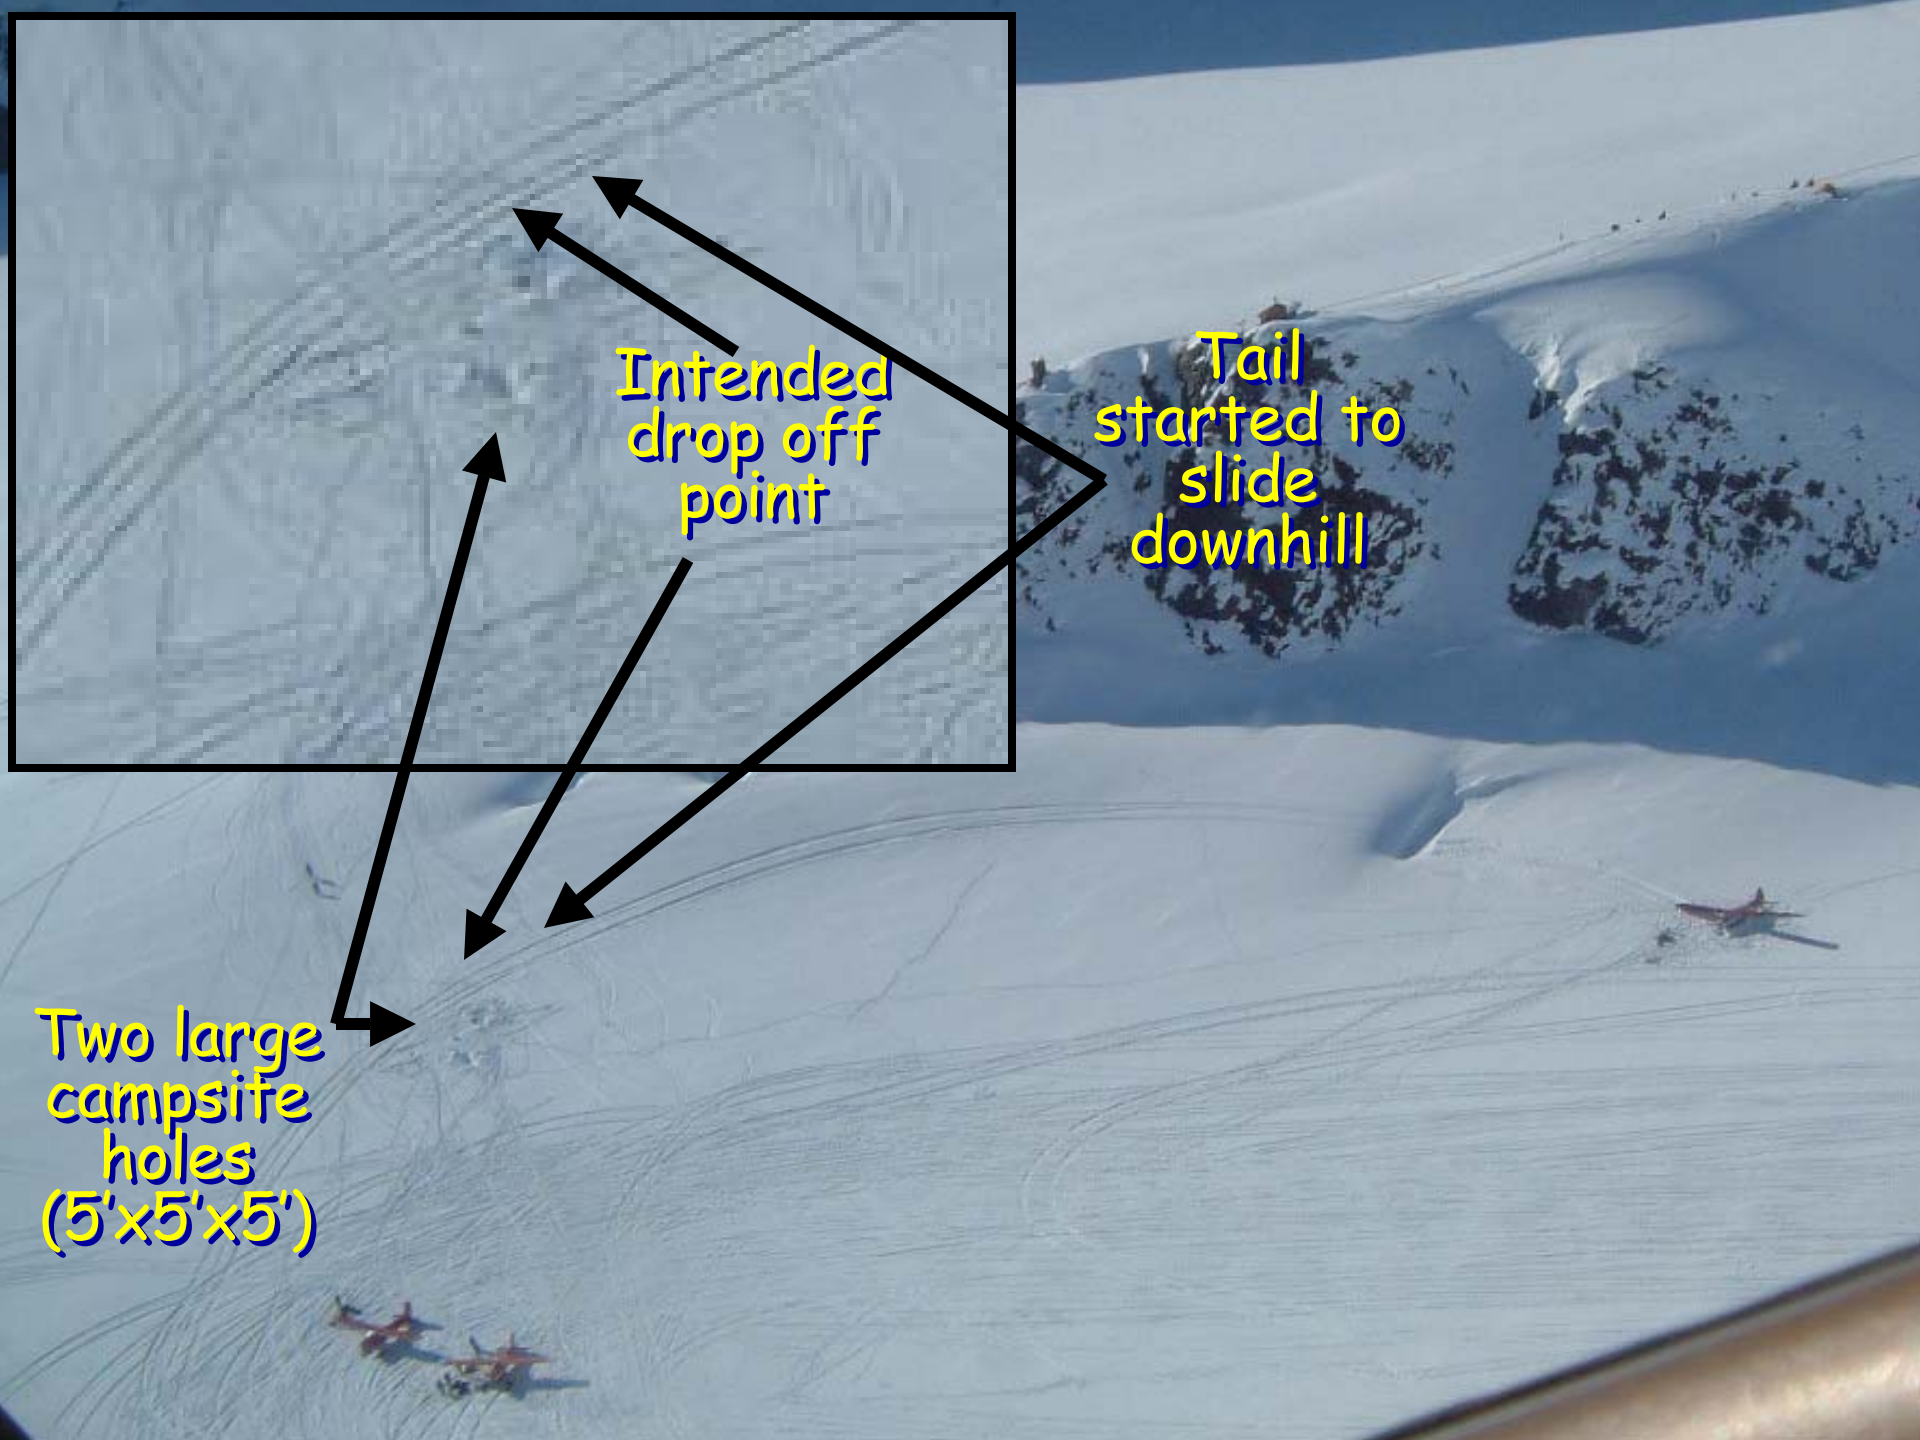
Intended
drop off
point

Tail
started to
slide
downhill

Two large
campsite
holes
(5'x5'x5')

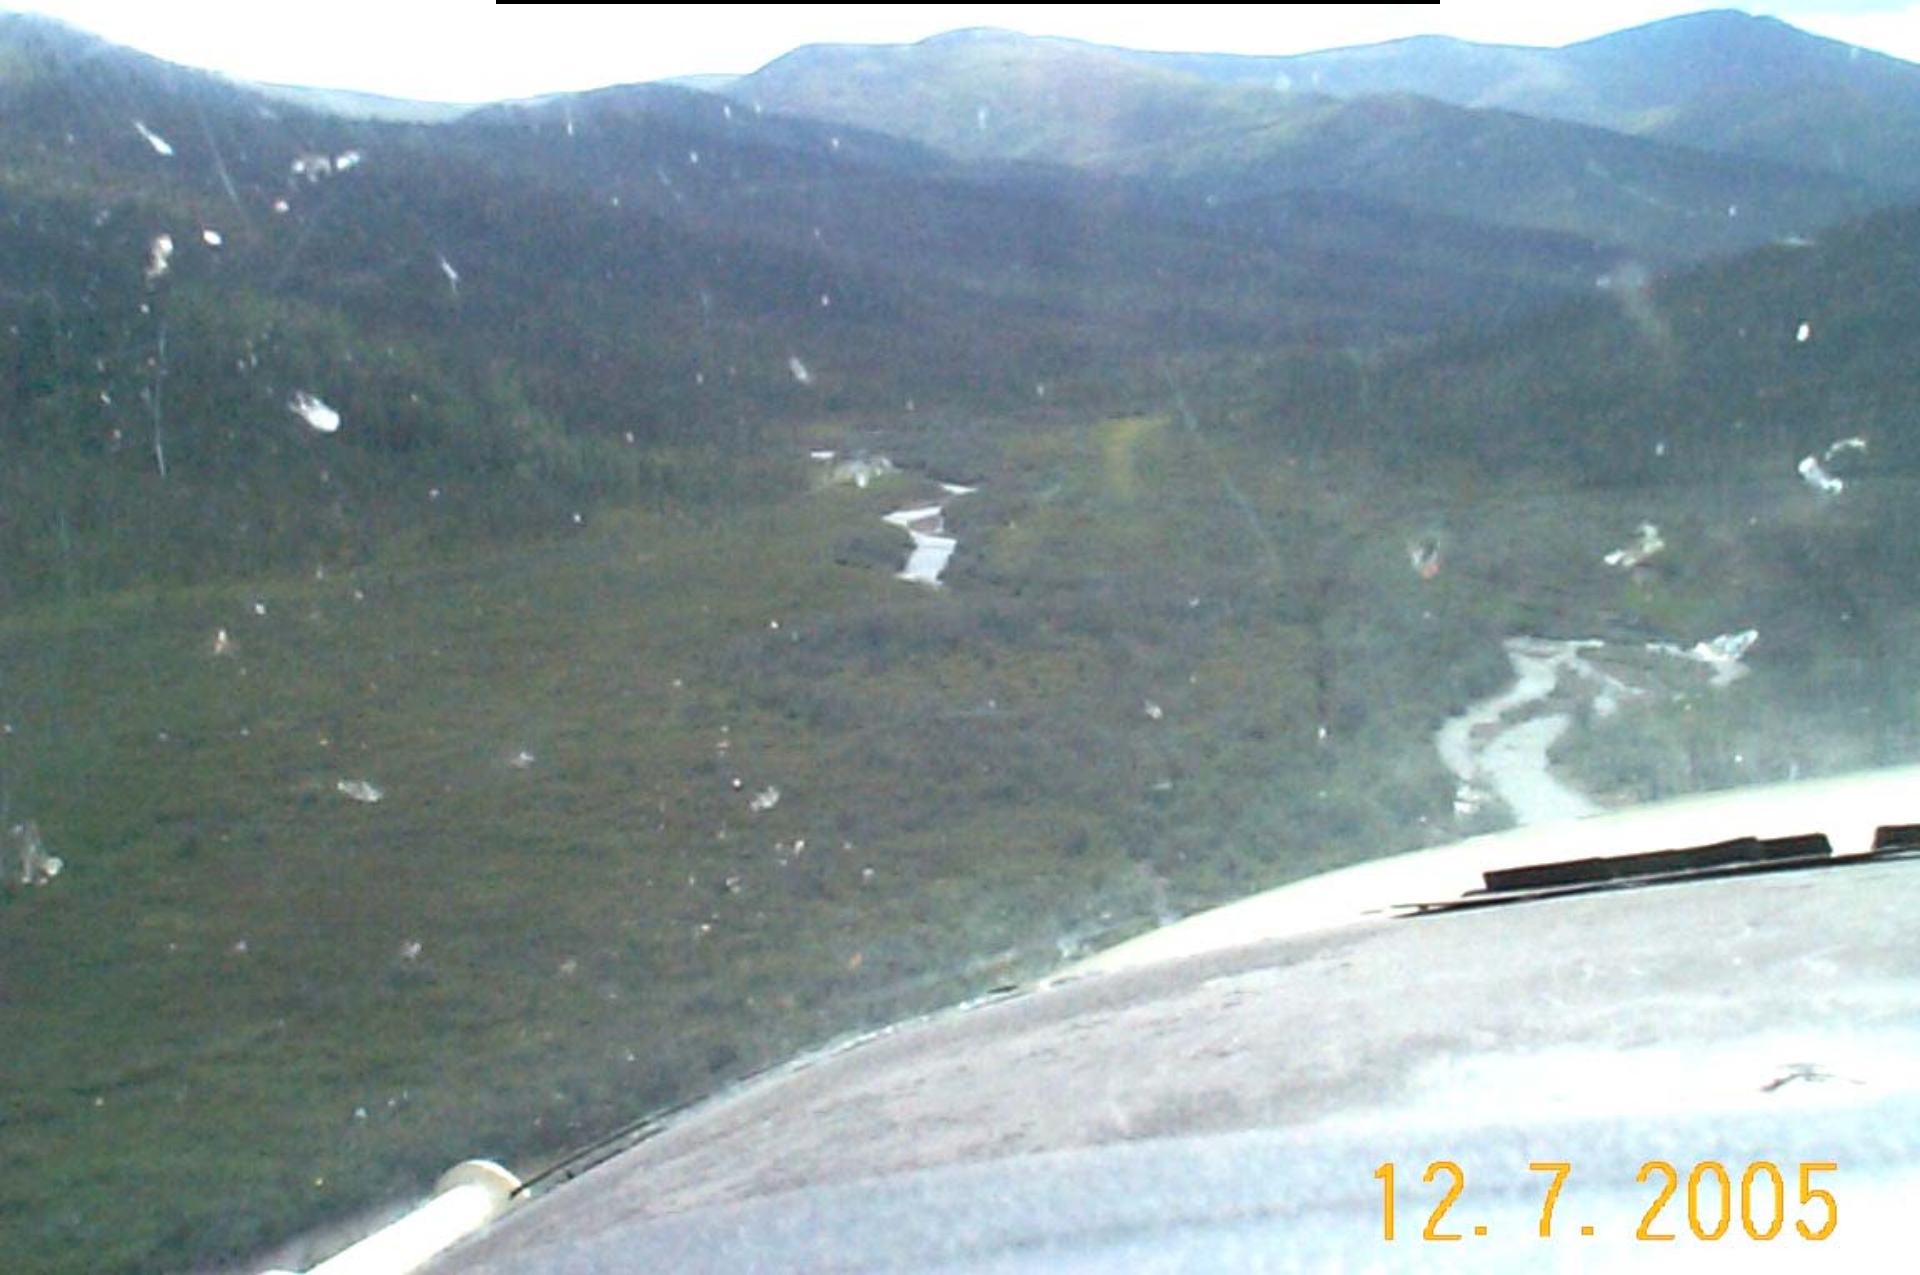
Final approach at
approximately 100' AGL

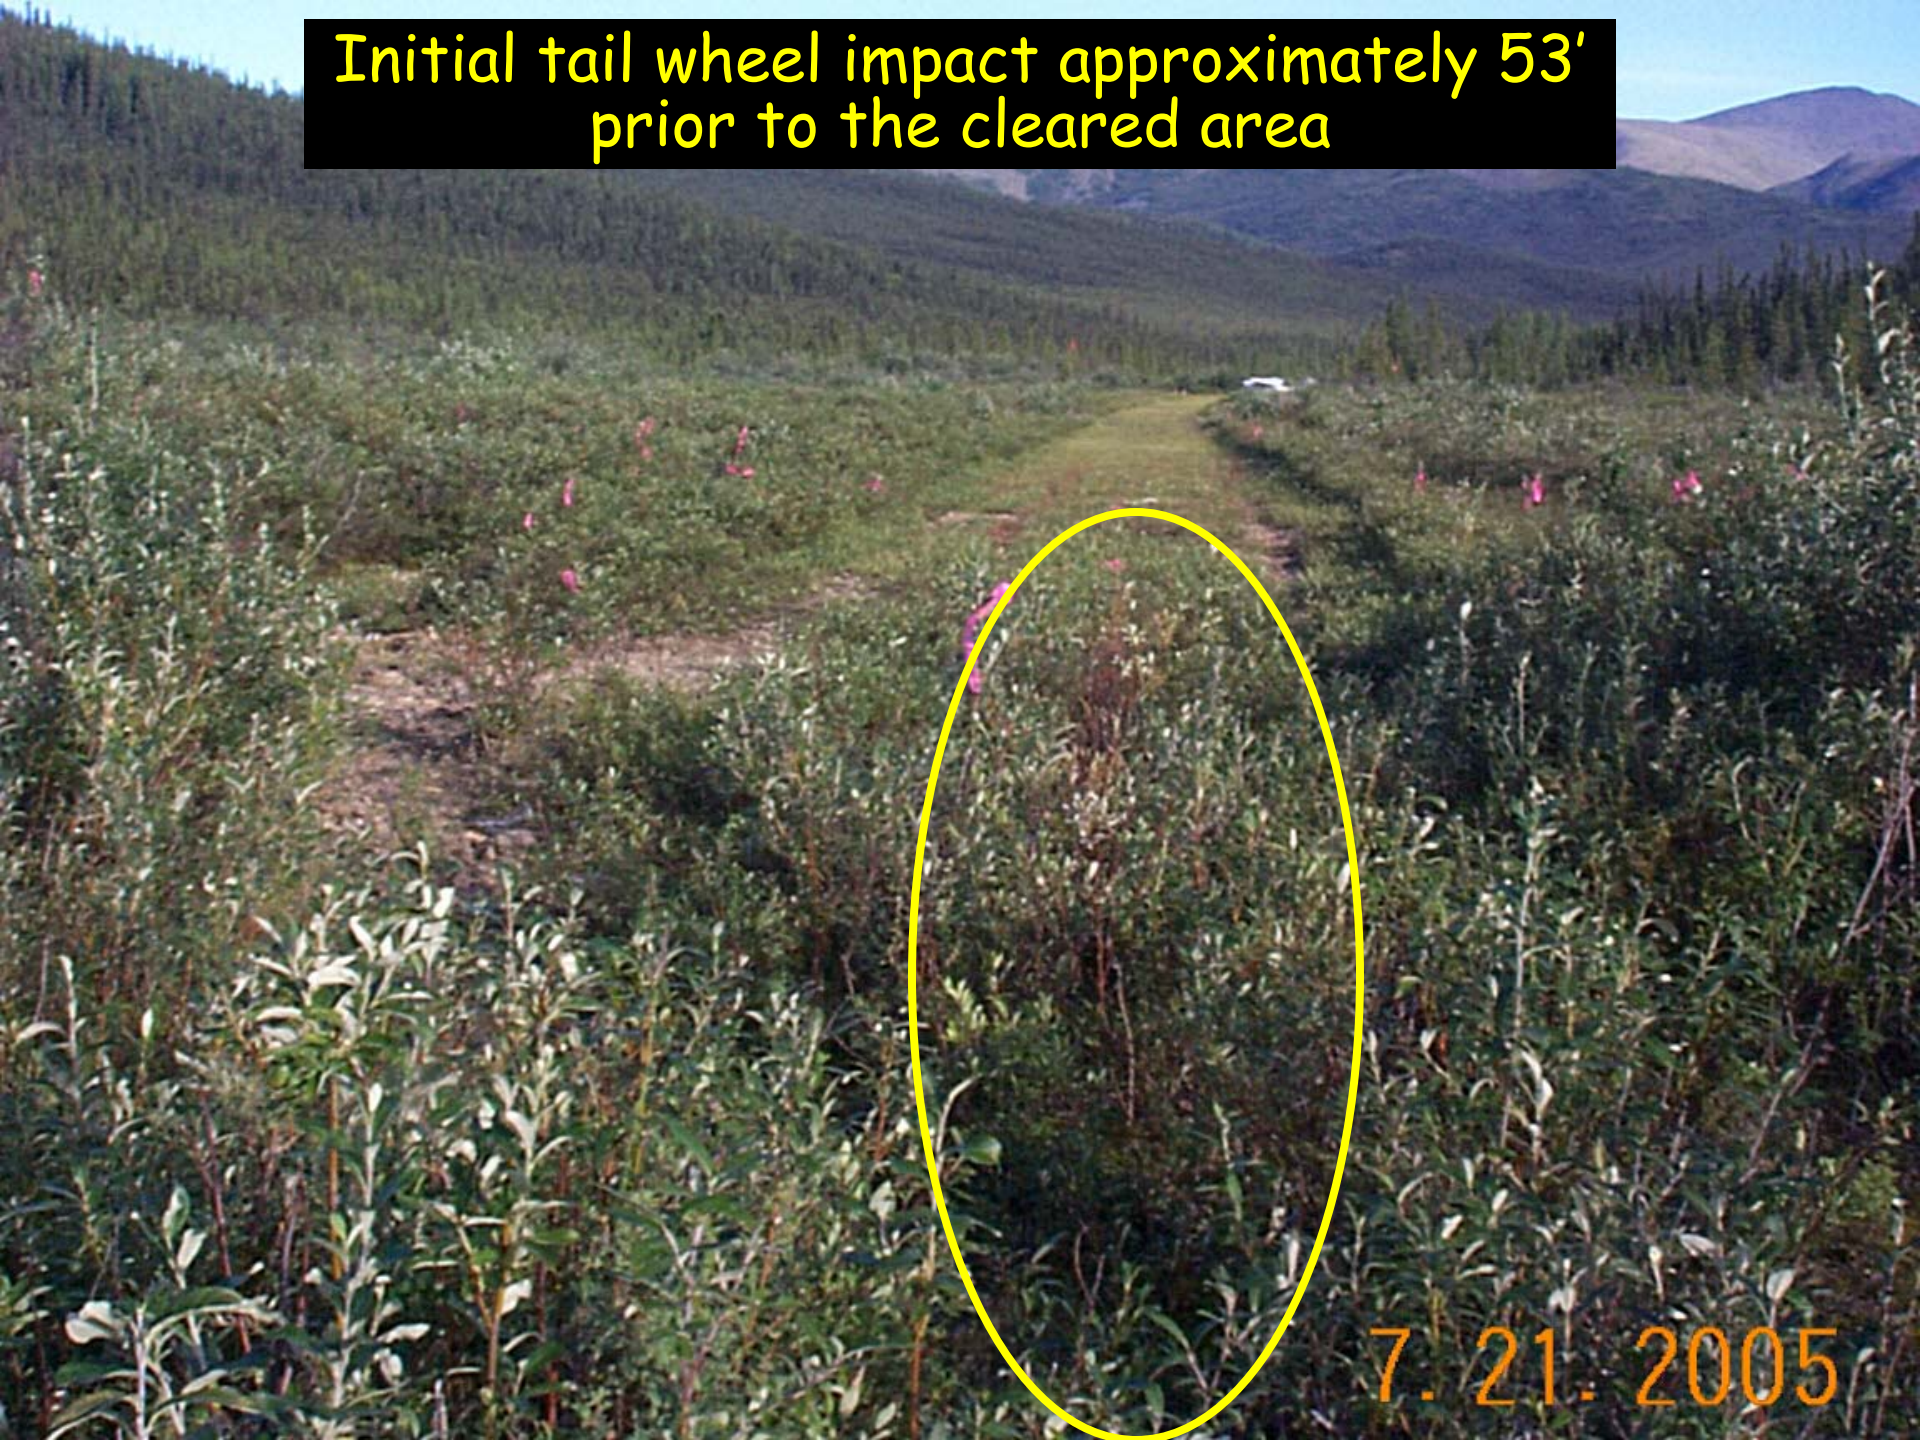
Initial tail wheel impact approximately 53'
prior to the cleared area

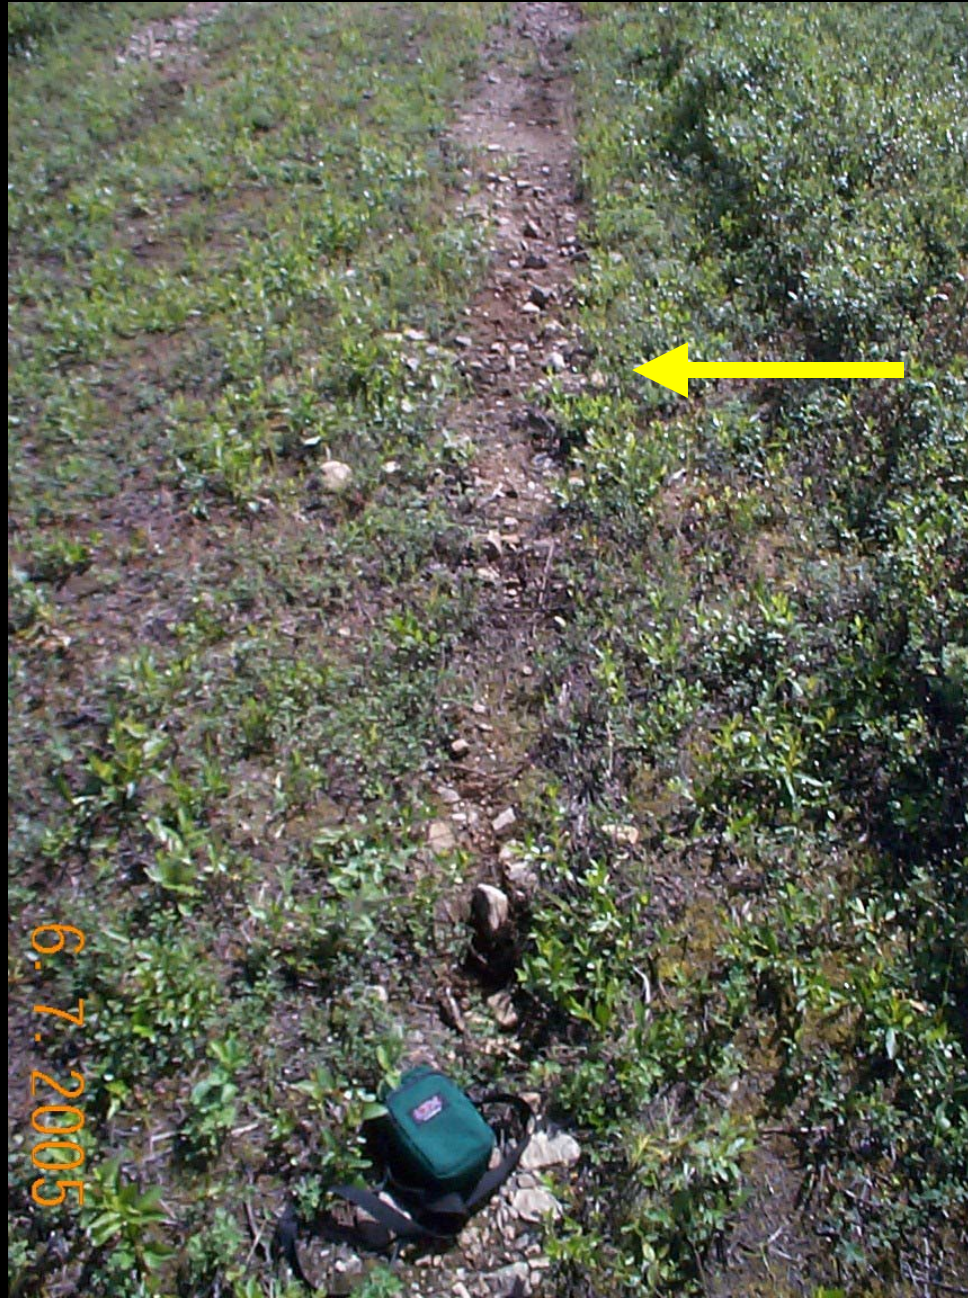
Rut where right main gear touched down

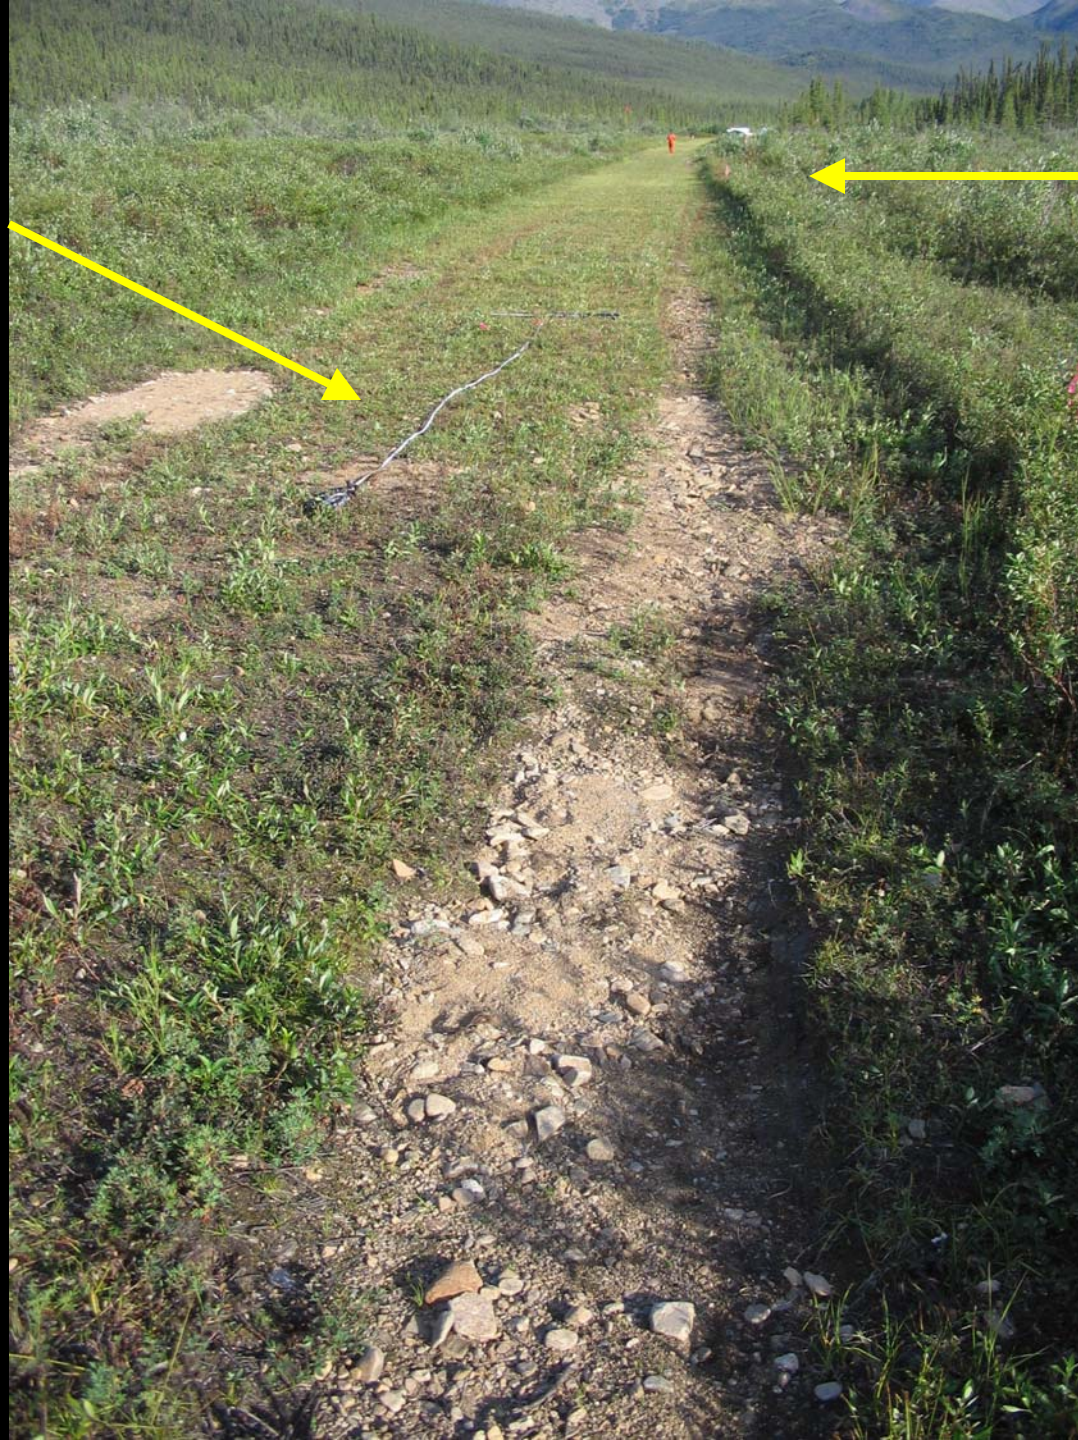
Area of
propeller
strikes

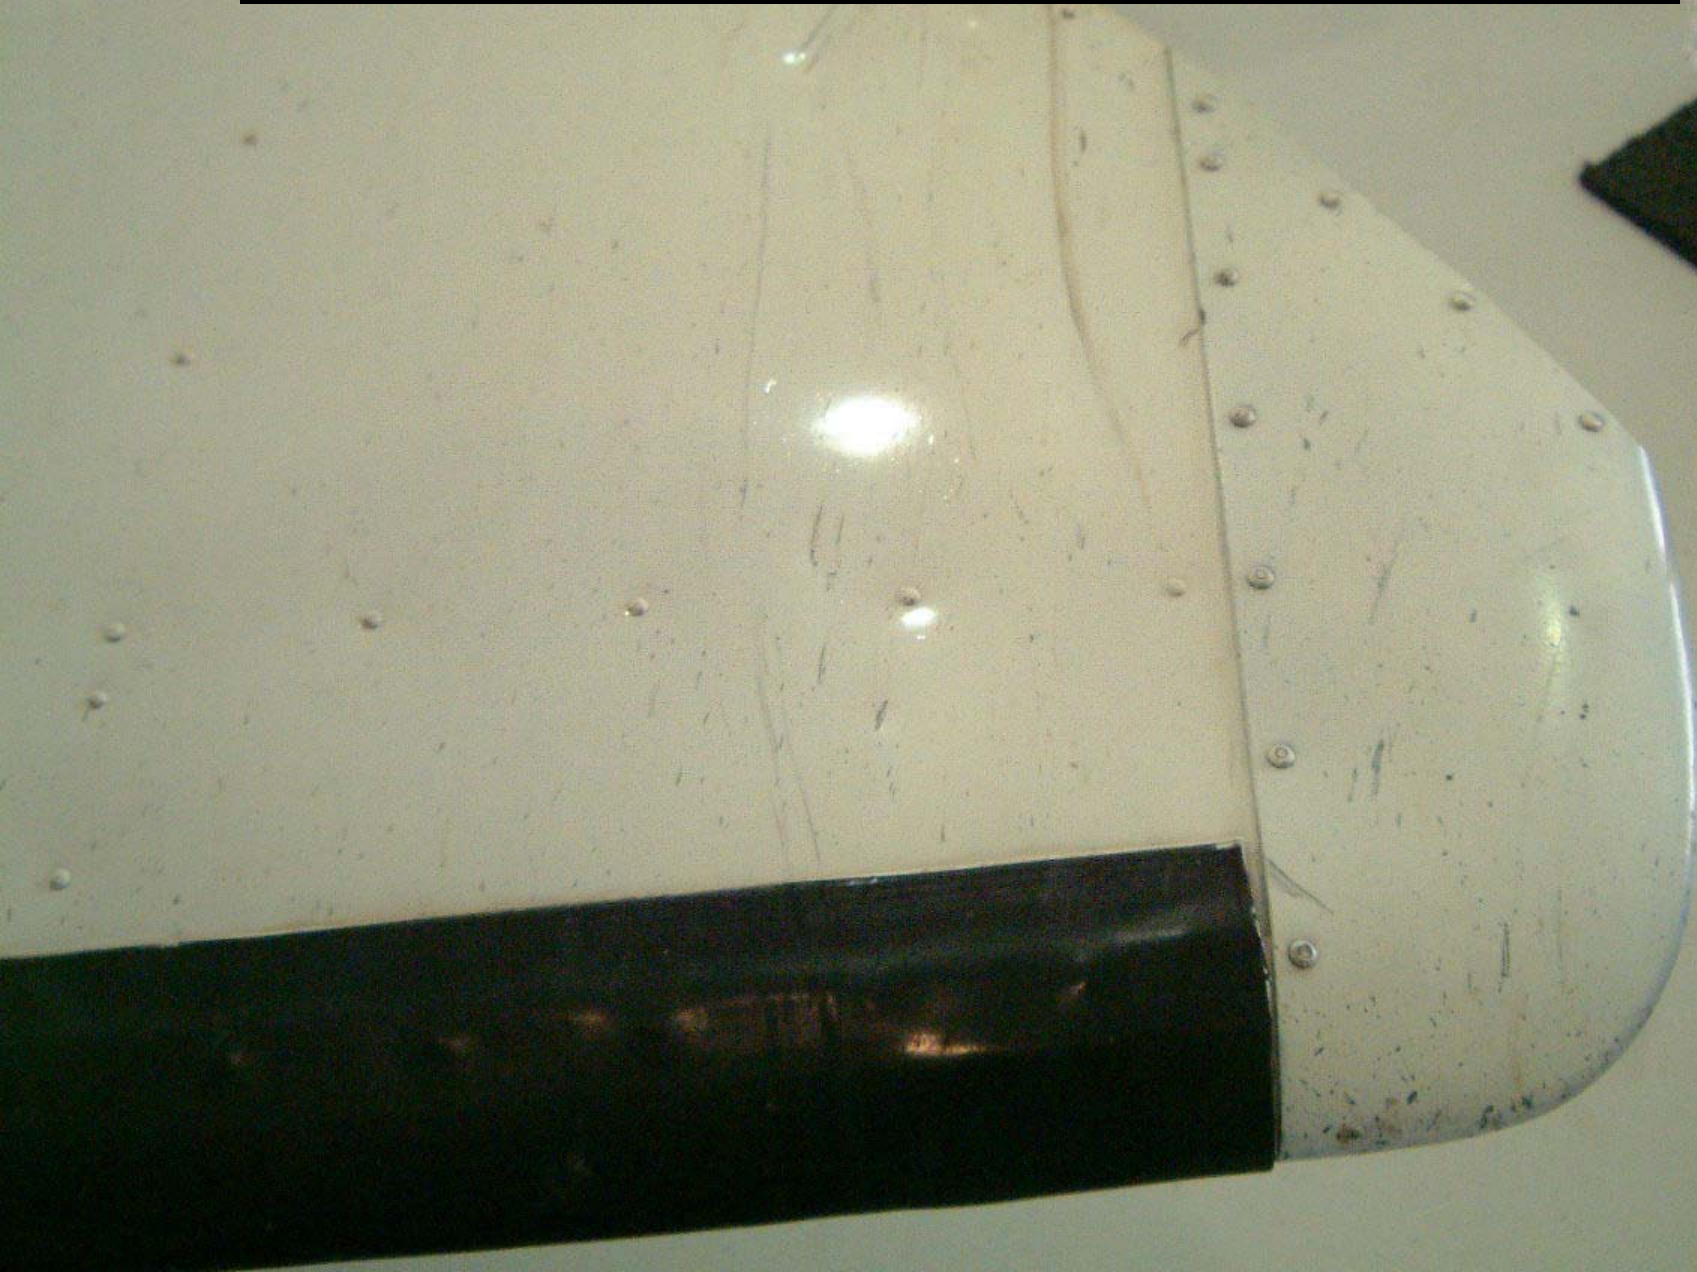
Scratch marks on the
underside of right-hand horizontal stabilizer

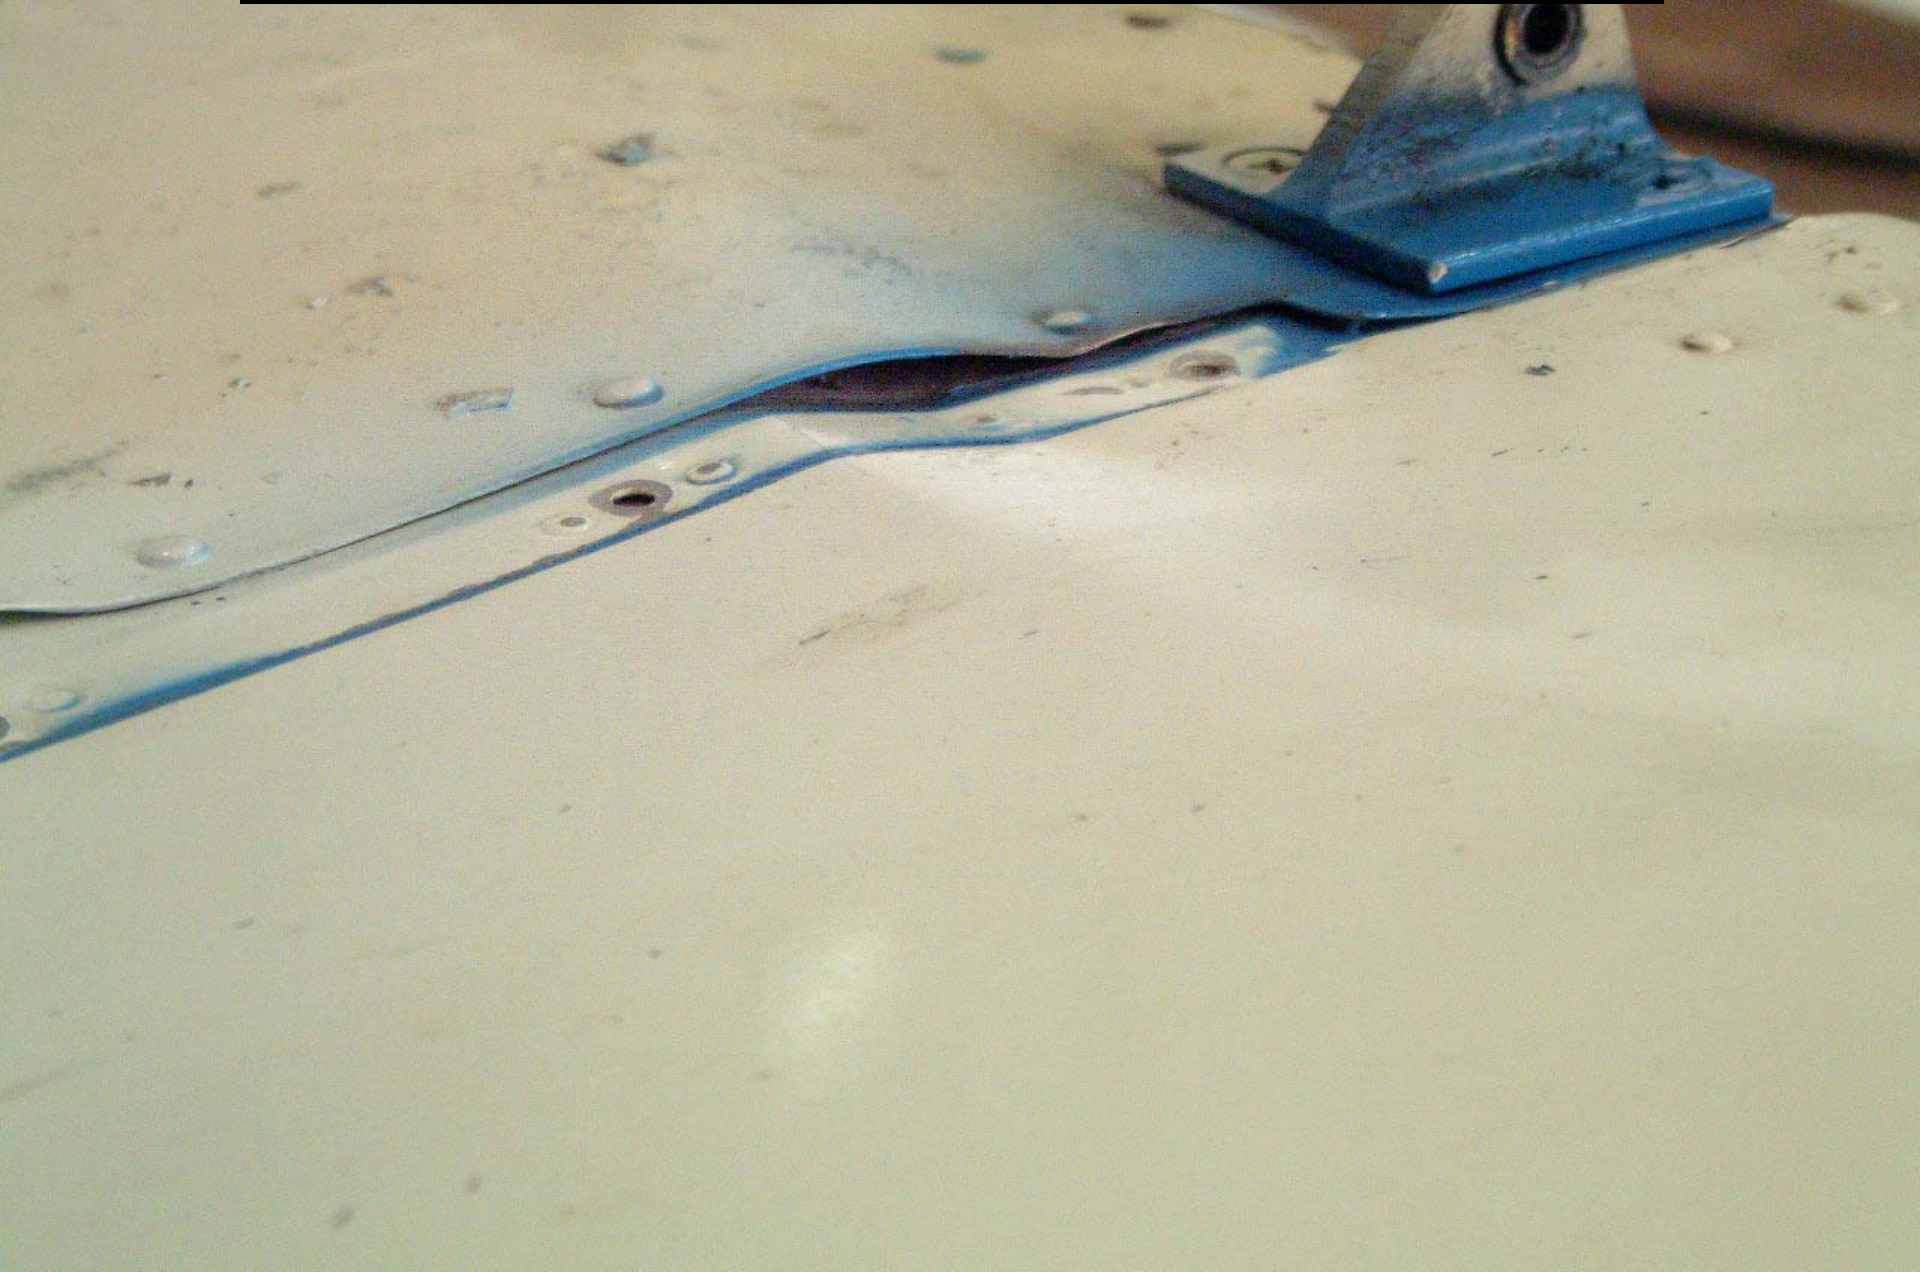
Wrinkling under a fairing at the inboard end
of the right-hand horizontal stabilizer

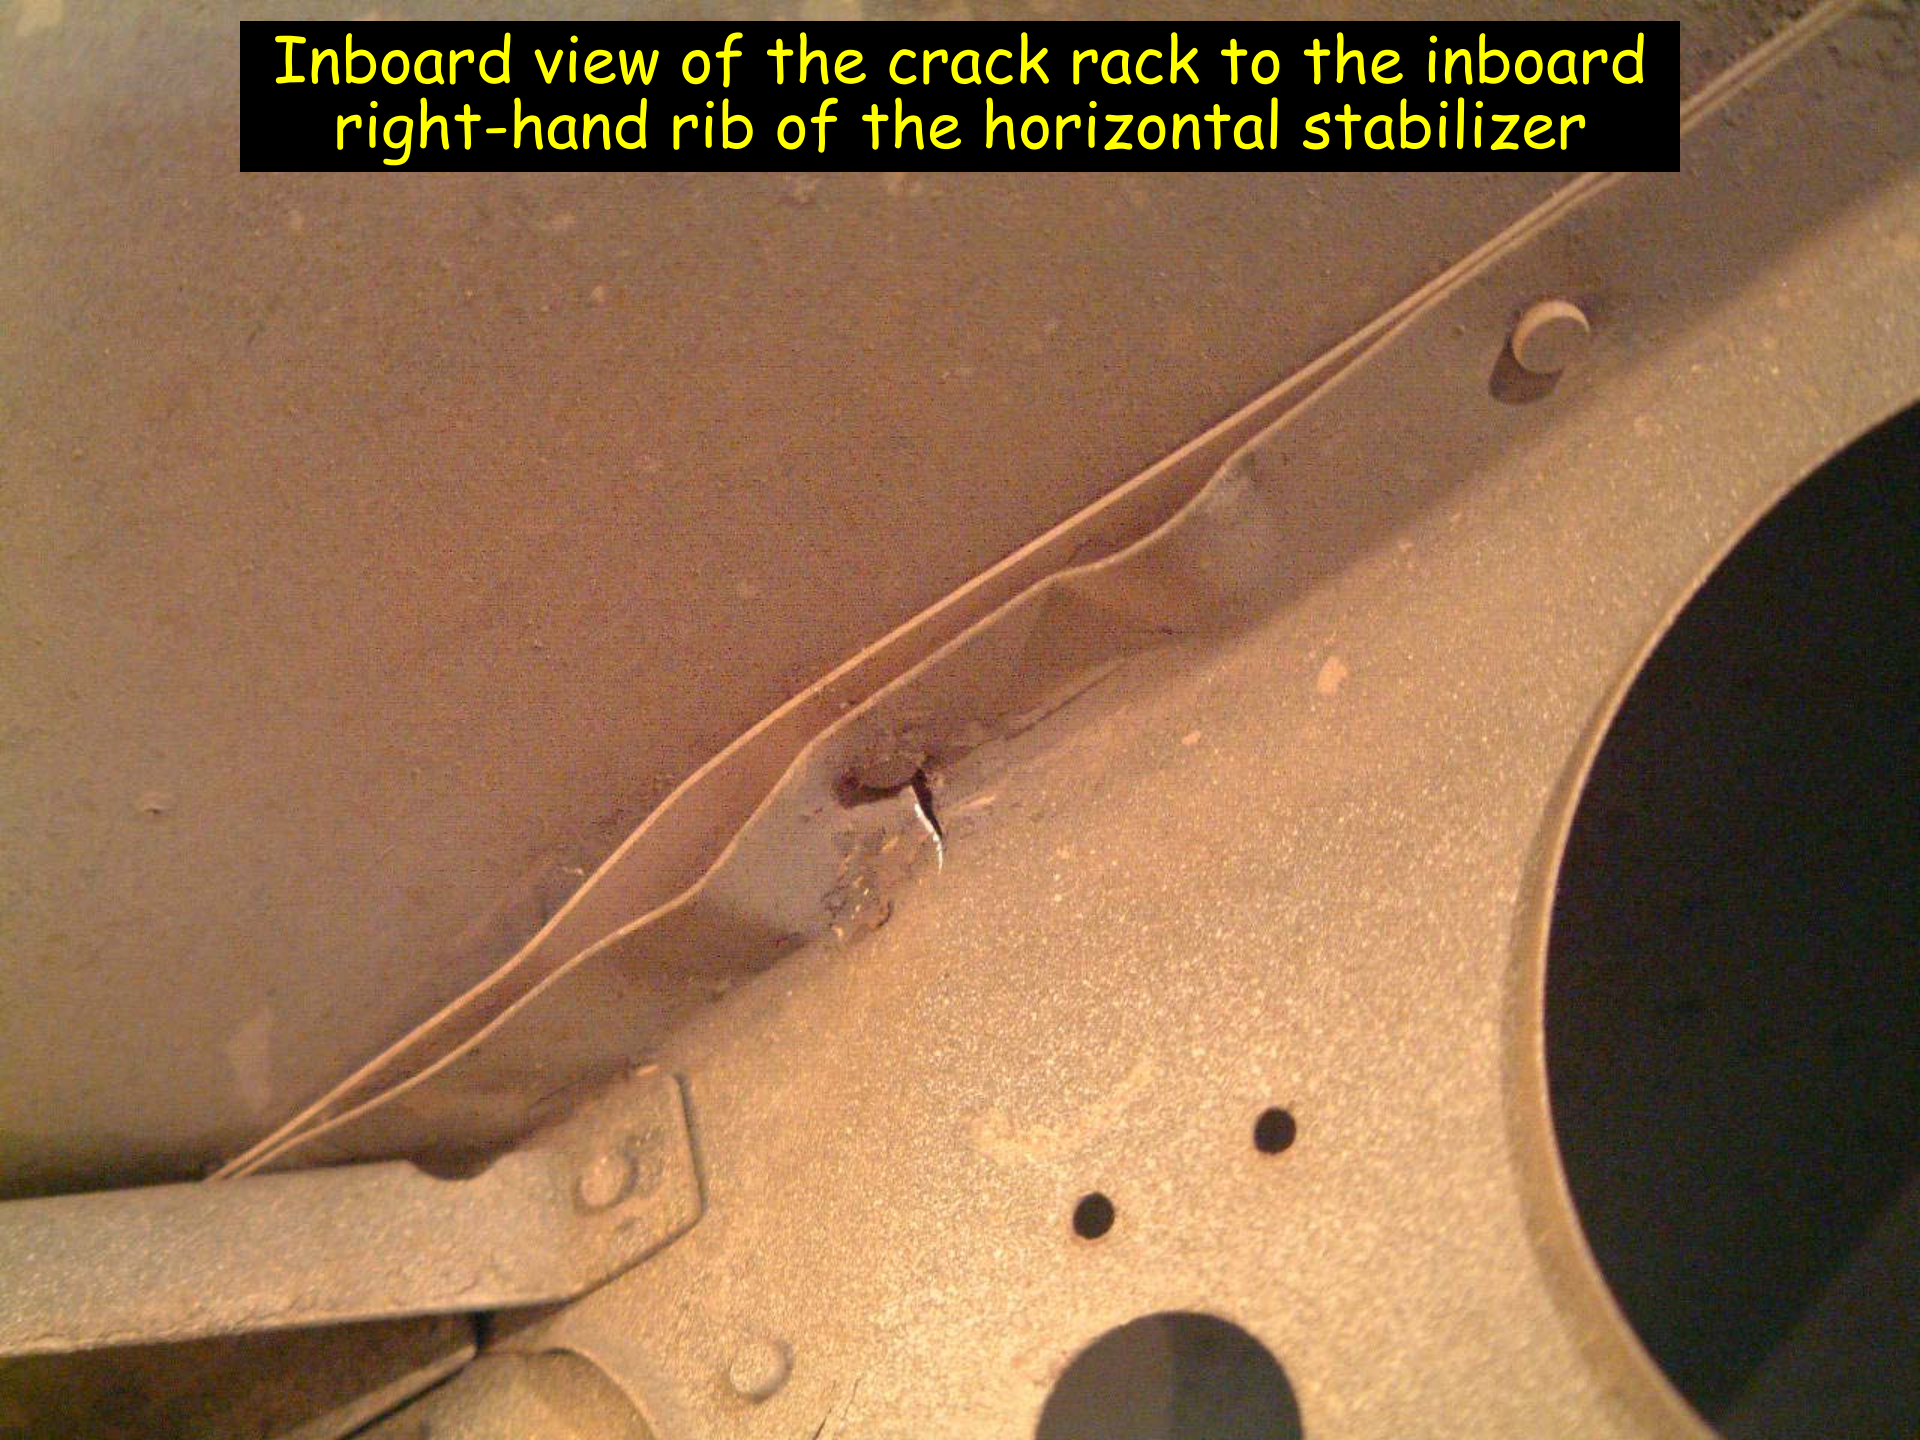
Inboard view of the crack rack to the inboard right-hand rib of the horizontal stabilizer
